# **DEVELOPMENT OF NEW PEDESTRIAN CROSSING GUIDELINES IN UTAH**

## **Technical Document**

Utah Department of Transportation Research and  
Development Division

Department of Civil and Environmental Engineering  
University of Utah

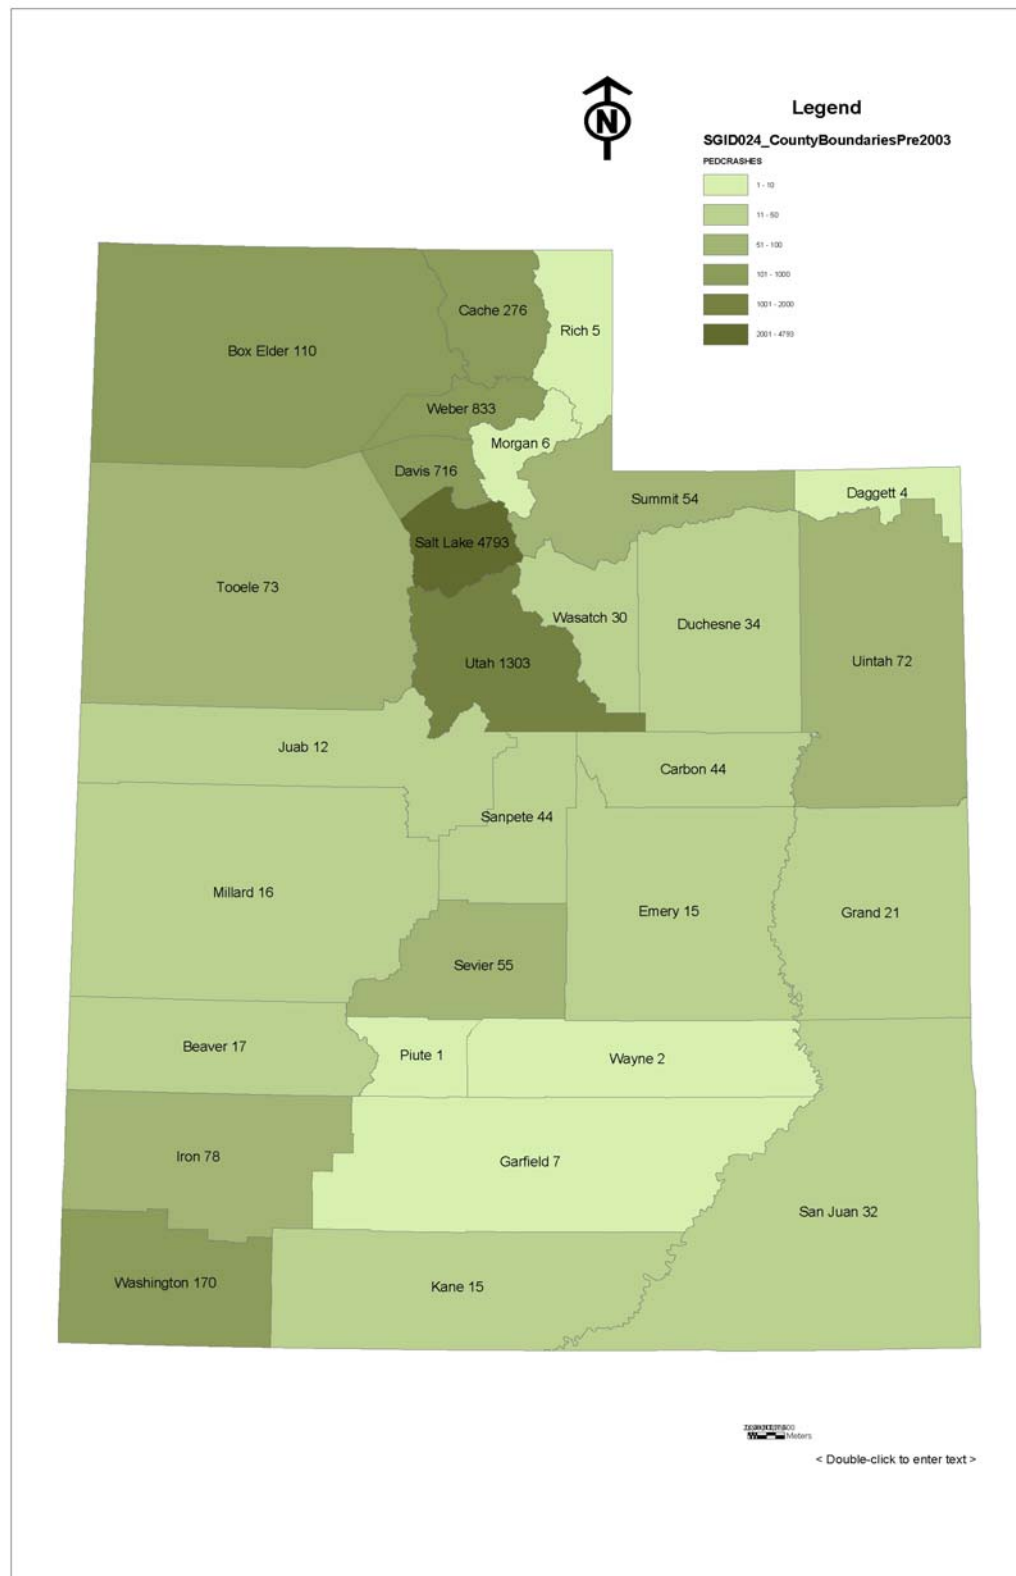
**Figure 1. Map: Pedestrian-Vehicle Crashes in Utah by County (1992-2001)**

vehicle collisions occurred in Utah between 1992 and 2001. Incidents occurring on private property were not recorded in the database after 1996, hence the apparent drop in pedestrian-vehicle incidents from 1996 to 1997. Between 1992 and 1996, the annual number of incidents remained fairly stable. Between 1997 and 2001, the trend was toward a decreasing number of incidents. In fact, the number of pedestrian-vehicle crashes decreased at a rate of 5.2% per year between 1997 and 2001. Multiple factors were likely involved in this trend, including a decreased amount of walking, improved pedestrian awareness of motor vehicles, improved driver awareness of pedestrians, infrastructure improvements such as lighting and signing, enforcement, and others. Despite these interventions, and the change in crash reporting policy, the research considered the entire ten years of data. The research team decided that the richness of ten years' worth of pedestrian-vehicle crash information should be utilized. Figure 1 shows the 10-year number of pedestrian-vehicle crashes by county.

The greatest number of pedestrian-vehicle crashes occurred, as expected, in Utah's most populous county, Salt Lake. A total of 4,793 crashes occurred, representing 54.2% of the State's crashes. The second greatest number of crashes occurred in Utah County, at 1,303 or 14.7% of the State's incidents. Salt Lake County was home to 39.6% of Utah's residents as of the year 2000 census. The portion of pedestrian-vehicle crashes occurring in Salt Lake County, therefore, exceeded the county's proportion of the state's population. There may be several reasons behind this finding, including a greater visitor population in Salt Lake County than in other counties (and a consequential lack of familiarity with the transportation system), and a higher level of pedestrian exposure to motor vehicle activity. Urban counties – Cache, Davis, Salt Lake, Utah, Washington, and Weber – experienced 8,091 pedestrian-vehicle crashes, or 91.5% of the State's total. Of the remaining 747 crashes, 69.1% (516) occurred in counties with small urban areas (urbanized concentrations with populations of 5,000 to 50,000: Box Elder, Carbon, Iron, Sevier, Summit, Tooele, Uintah, and Wasatch). Thus, 91.5% of the State's pedestrian-vehicle crashes occurred in urban counties, 5.8% occurred in counties with small urban areas, and 2.6% occurred in the 15 rural counties. Although pedestrian safety is a statewide issue, pedestrian safety breaches most commonly occurred in urban settings during the study period.

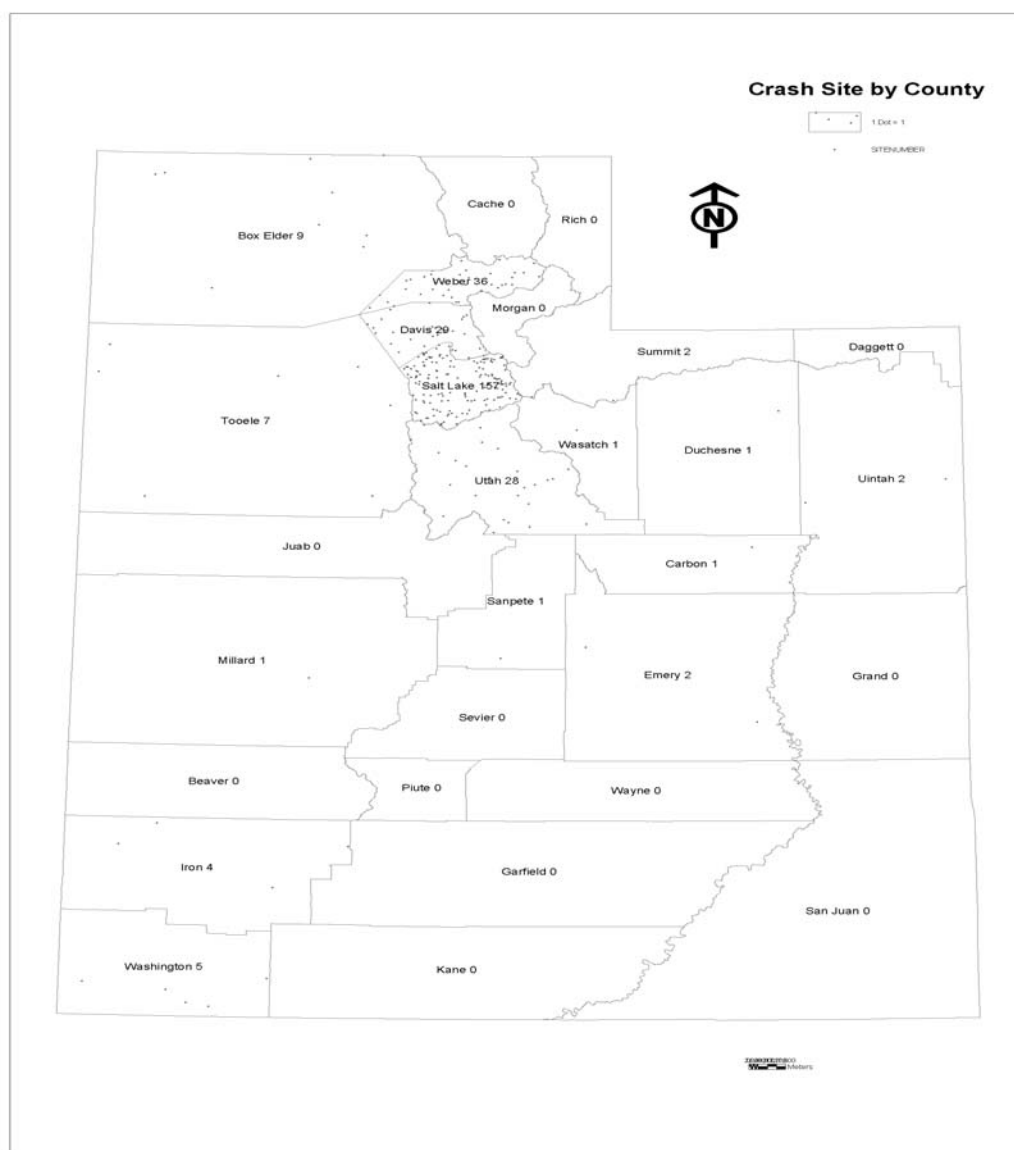
**Figure 2. General Locations of Sampled Pedestrian-Vehicle Crash Sites**

Further details on the pedestrian-vehicle crash sites are presented in Chapter 5. Figure 2 displays the approximate statewide distribution of the sampled crash sites.

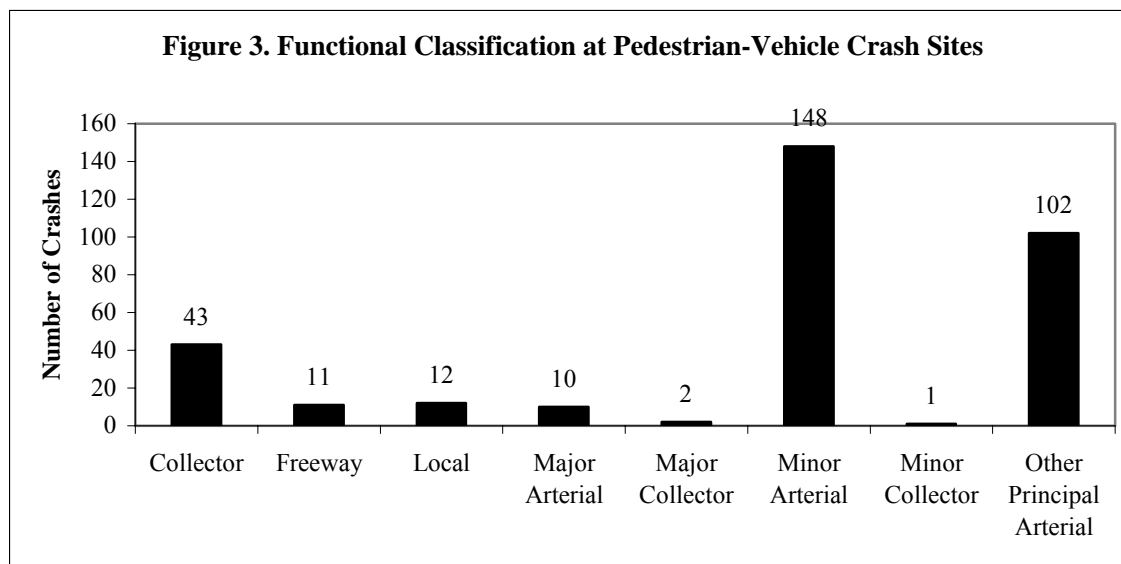
Nearly half (148 or 45.0%) of the pedestrian-vehicle incidents in the sample occurred along minor arterials, as shown in Figure 1. An additional 102 (31.0%) occurred on other principal arterials, while 43 (13.1%) occurred on collectors. Of the 36 remaining incidents, 12 occurred on local streets, 11 occurred on interstate freeways, and ten occurred on major arterials (a rural designation). Urban arterials, therefore, were the scene of 76.0% (250) of the collisions. All of the freeway incidents were single fatal crashes. The sample was designed to emphasize high-severity crash sites, so it would be an incorrect to conclude that *all* freeway pedestrian-vehicle collisions are fatal (although a large portion of them probably are). About two-thirds (29) of the collectors intersected with minor or other principal arterials at pedestrian-vehicle crash sites. Similarly, just over half of the local streets (7) intersected with arterials at pedestrian-vehicle crash sites. Many of the crashes at these sites were “attributed” to the arterials.

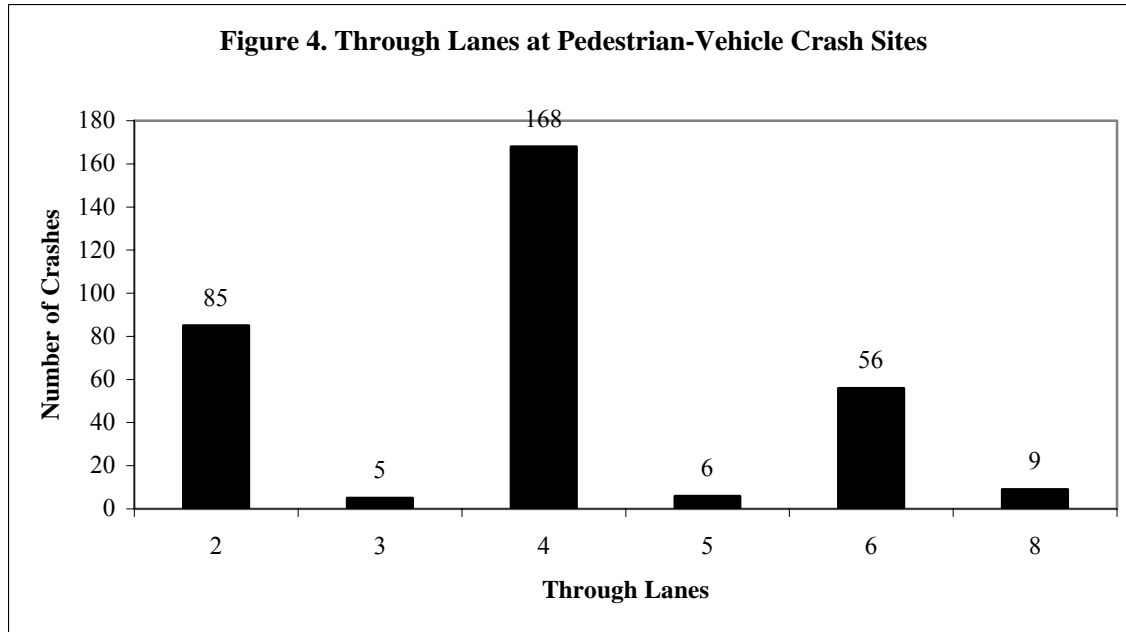
Just over half (168 or 51.1%) of the pedestrian-vehicle crashes occurred at locations at which there were four through lanes, as presented in Figure 2. It should be noted that the number of lanes recorded in the CDDS is not necessarily the number of lanes that the pedestrian has to cross. The research team observed that, at many sites, there were often one or more turning lanes, along with one or more shoulders (striped or unstriped). The number of lanes in the CDDS, therefore, is not necessarily indicative of the pedestrian

crossing distance. The number of through lanes nonetheless provides a useful, general statistic that can be used to compare sites. Two-lane sites were the next most “popular” pedestrian-vehicle location, with 85 (25.8%) of all sites. A total of 56 (17.0%) of the sites had six through lanes. In reference to the preceding discussion, the research team found that pedestrian crossing distances could be confirmed only through site visits.

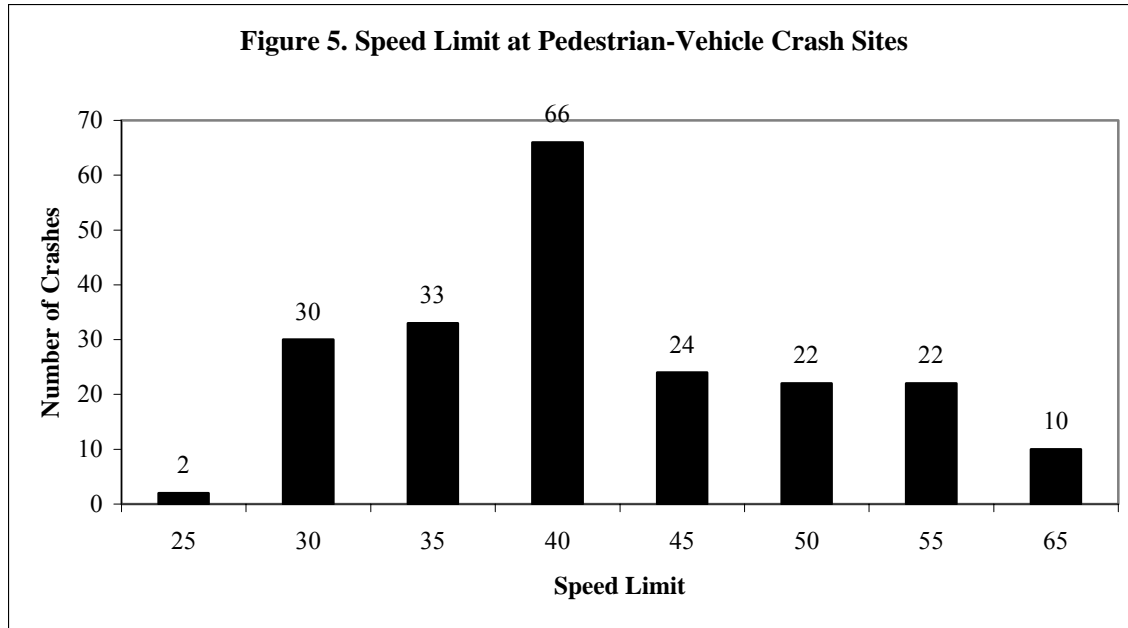
The speed limits at the pedestrian-vehicle crash sites ranged from 25 to 65 MPH, as shown in Figure 3. The speed limit was not necessarily the *actual speed* of the motor vehicle at the moment of impact, but it is nonetheless a useful guideline. The speed limit at 66 (20.1%) of the crash sites was 40 MPH. The Final Report (the Technical Document – this document – is a companion to the Final Report) identifies 45 MPH as a threshold speed for marked crossings at uncontrolled locations. That is, at speeds (actually, 85<sup>th</sup> percentile speeds) less than 45 MPH, a marked crossing *may* be recommended at an uncontrolled location if other criteria are satisfied. A marked crossing at an uncontrolled location is generally not recommended, though, when the speed is 45 MPH or more. The data indicate that 78 (23.7%) of the pedestrian-vehicle crash sites occurred where the speed limit was 45 MPH or more. A total of 63 of these sites (about 80%) were uncontrolled. The supposition is that these 63 sites would *not* be eligible for marked crossings without the introduction of some form of traffic control (stop sign or traffic signal). A number of interventions might be considered at these locations to prevent further pedestrian-vehicle incidents, such as:

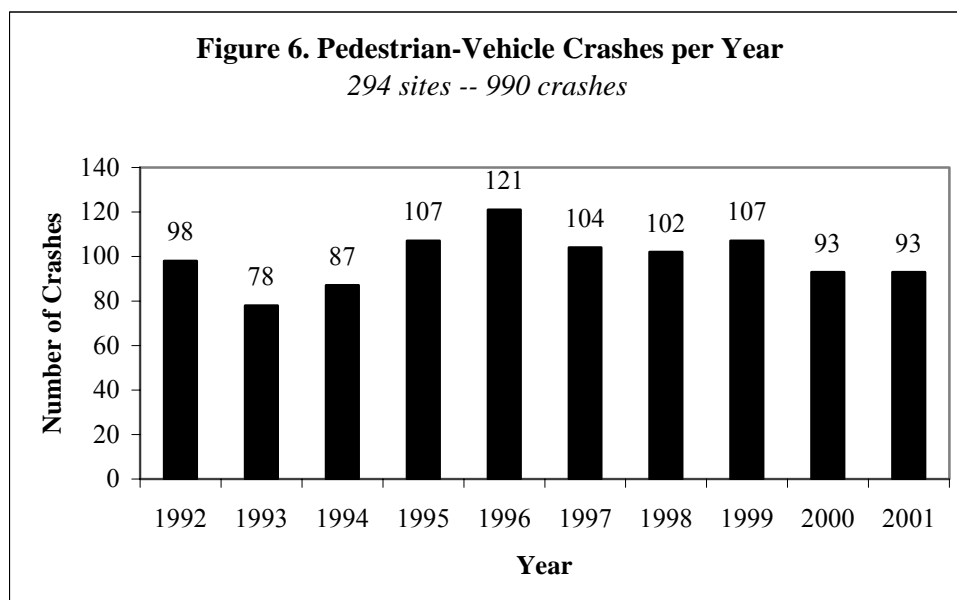
**Year.** A discussion of the number of pedestrian-vehicle crashes occurring each year during the 1992-2001 study period was provided in Chapter 3 of this document. A declining trend in the number of pedestrian-vehicle crashes per year was noted. A substantial dropoff in the number of crashes from 1996 to 1997 was attributed to a change in UDOT's crash reporting policy. Within the sample of 294 pedestrian-vehicle crash sites, though, there was no discernible trend. That is, the number of crashes remained fairly steady from 1992, in which there were 98 incidents, to 2001, in which there were 93 incidents. The year 1996 crashes, at 121, were the highest of the study period; the drop to 104 crashes in 1997 was probably directly related to the change in crash reporting policy. The values are displayed in Figure 4. The indication is that the sites chosen for the sample remained, perhaps, "unimproved" for the duration of the study period. That is, external factors such as changes in the amount of motor vehicle traffic, changes in the amount of walking, safety improvements, and so forth did not have a noticeable effect on the annual crash figures.

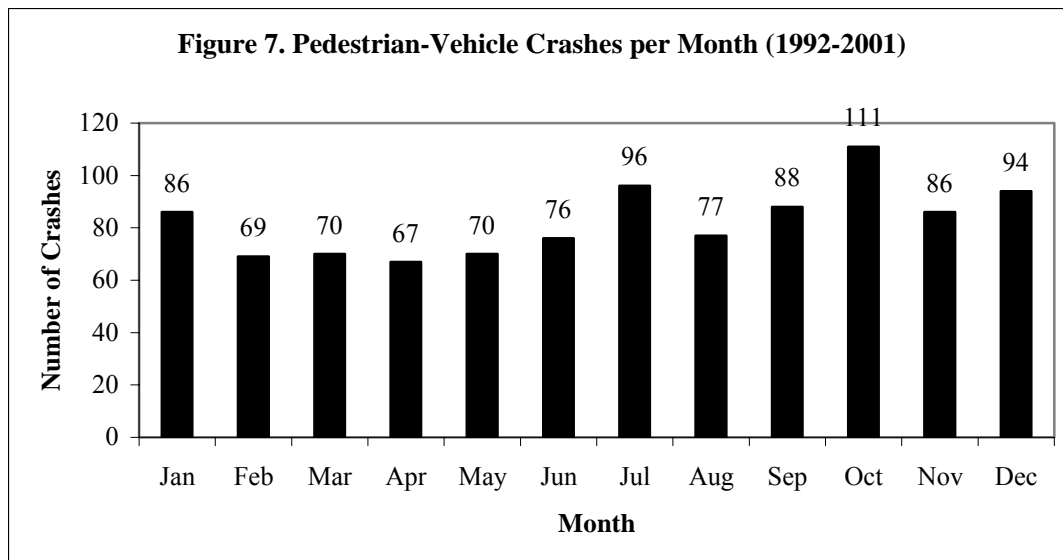
**Month.** By month of the year, over the 10-year study period, the number of pedestrian-vehicle crashes ranged from 67 in April to 111 in October. The average number of crashes per month was 82.5, and the median was 81.5. October was by far the "busiest" month for pedestrian-vehicle crashes, although its value was not quite an outlier. A combination of school and recreational activities, along with moderate temperatures were probably factors in making October the busiest month for pedestrian-vehicle incidents. The second-busiest month was July, a mid-summer month, at 96 incidents, followed by December with 94 incidents. The heavy pedestrian-vehicle crash activity in December was contrary to the presumption that a winter month would see a lower amount of pedestrian activity. One conclusion is that October may be a choice month during which to conduct pedestrian volume counts or surveys. The statistics are summarized in Figure 5.

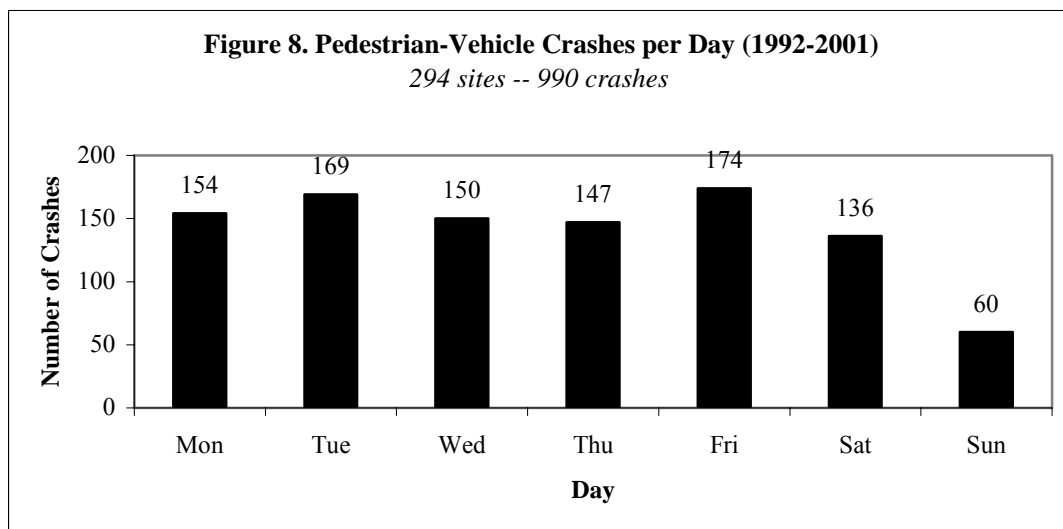
Day of the Week. Over the 10-year study period, the number of pedestrian-vehicle crashes ranged throughout the week from 154 on Mondays to 136 on Saturdays, with Friday as the peak day (174 incidents). Tuesday was the second most active day, with 169 crashes. Sunday was an outlier, with just 60 incidents. It is evident that Sunday saw a reduced amount of pedestrian activity, or at least a decrease in pedestrian exposure to motor vehicles, when compared to the other days of the week. The day of the week statistics are summarized in Figure 3. From Monday to Saturday, the average number of pedestrian-vehicle incidents per day was 155, with a standard deviation of 14.20. The coefficient of variation (the ratio of the standard deviation to the mean) was just 0.092, indicating that the variation about the mean, from day to day, was not substantial.

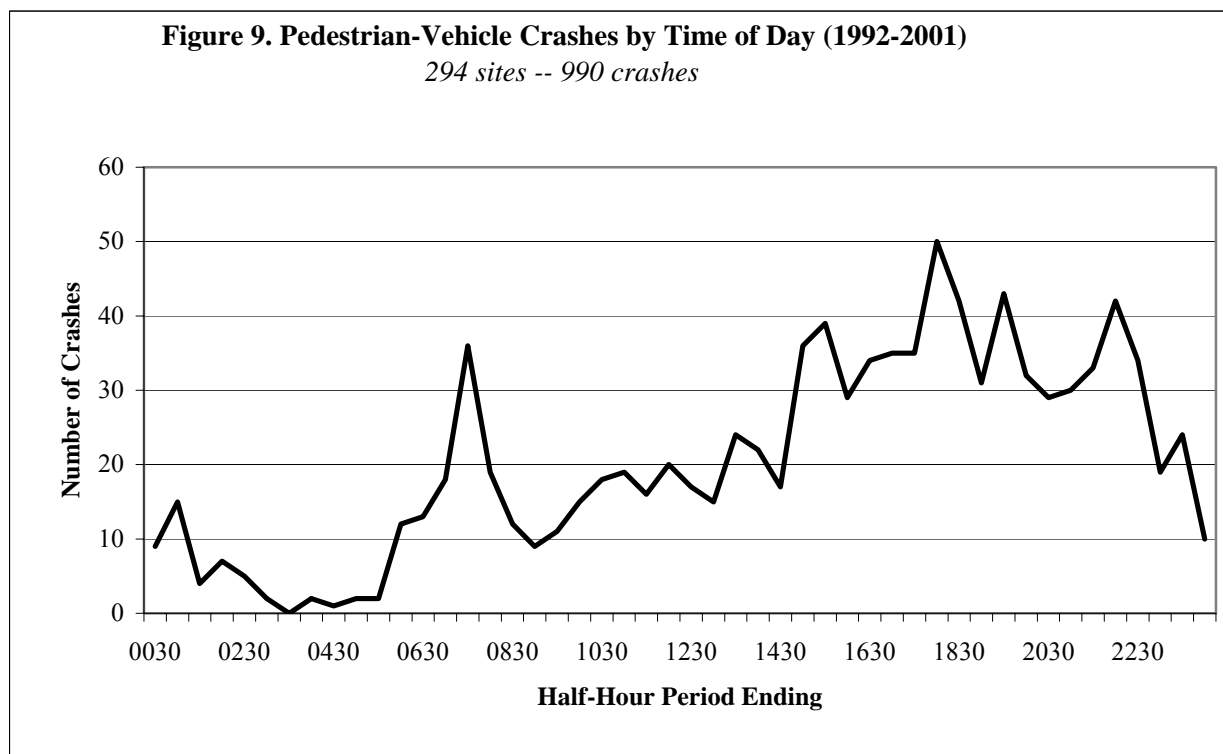
Time of Day. The 990 pedestrian-vehicle crashes occurring at the 294 sampled sites between 1992 and 2001 were tabulated according to the time of day of the incidents. Thirty-minute time blocks were used. Figure 4 displays the time distribution of crashes. The peak 30-minute period occurred from 5:30 to 6:00 PM, with 50 incidents, and the peak hour was from 5:30 to 6:30 PM, with 92 incidents. The peak two-

hour period was from 5:30 to 7:30 PM (166 incidents); the peak three-hour period was from 4:30 to 7:30 PM (236 incidents); the peak four-hour period was from 4:00 to 8:00 PM (302 incidents); and the peak eight-hour period was from 2:30 to 10:30 PM (574 incidents, or 58.0 % of all incidents). The evidence is that pedestrian-vehicle crashes were most prominent during mid- and late-afternoon hours, along with early- and late-evening hours. A small morning peak occurred between 7:00 and 7:30 AM (36 incidents); otherwise, no more than 24 incidents occurred during any other half-hour period outside of the peak eight hours. Incident totals remained between 9 and 24 per half-hour between 7:30 AM and 2:30 PM. Only 25 crashes occurred during late-night hours (1:00 to 6:00 AM). The data are displayed in Figure 7.

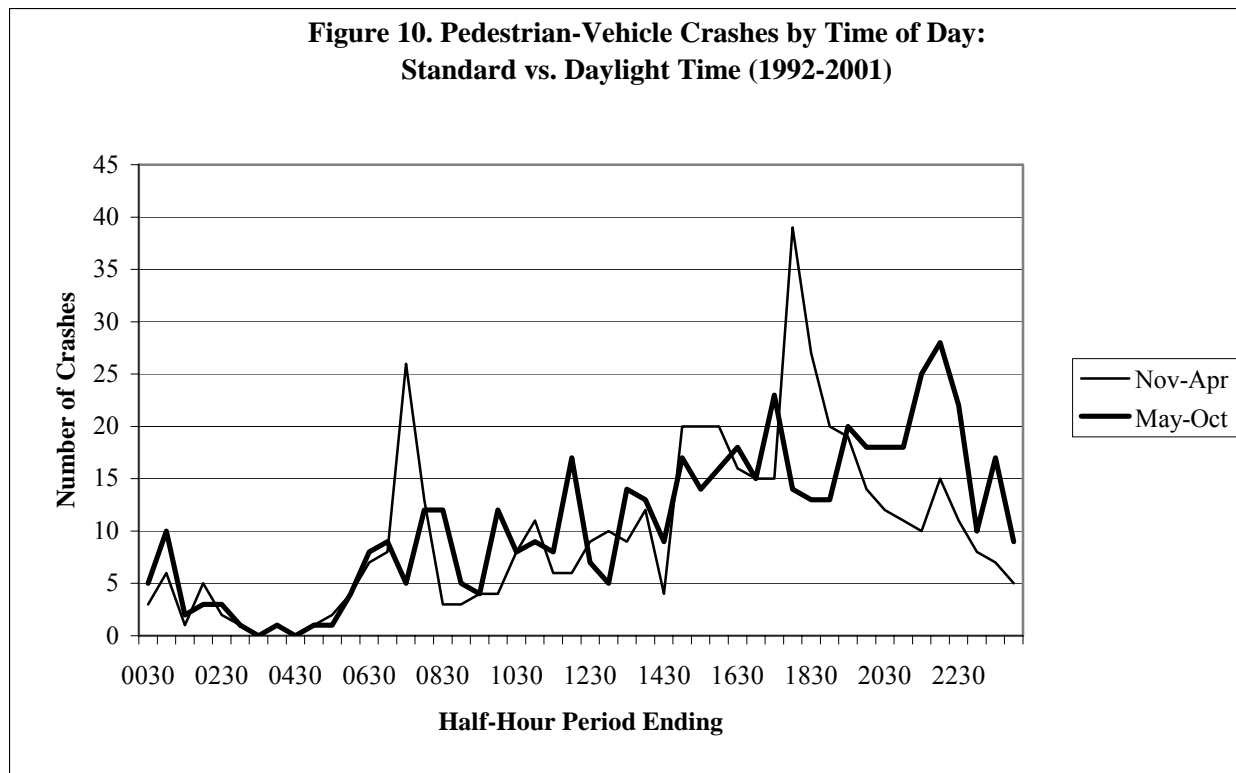
There was a supposition that the distribution of crashes might vary by season of the year; that is, according to the length of daylight per day. To examine this possibility, Figure 8 displays the time-of-day distribution of pedestrian-vehicle incidents by “standard” time months (November through April) and “daylight savings” time months (May through October). A total of 474 pedestrian-vehicle crashes (47.9%) occurred between November and April, while 516 (52.1%) occurred between May and October. Reading from the left, the two distributions were strikingly similar until the evening hours (5:30 PM to 12 midnight). The exception was a 7:00-7:30 AM peak that occurred during the November-April months that was absent during the May-October period. Around 5:30 PM, the November-April distribution surged toward an evening peak, while the May-October distribution dipped. Then, around 7:30 PM, the May-October distribution began to surge, while the November-April curve began a decline. The indication is that there was a greater amount of pedestrian activity and exposure during the late evening and early nighttime hours between May and October than there was during the November-April months. Indeed, the peak pedestrian-vehicle “crash hour” was from 5:30 to 6:30 PM between November and April, but between 9:00 and 10:00 PM from May to October. At both times of the year, the peak occurred outside of daylight hours.

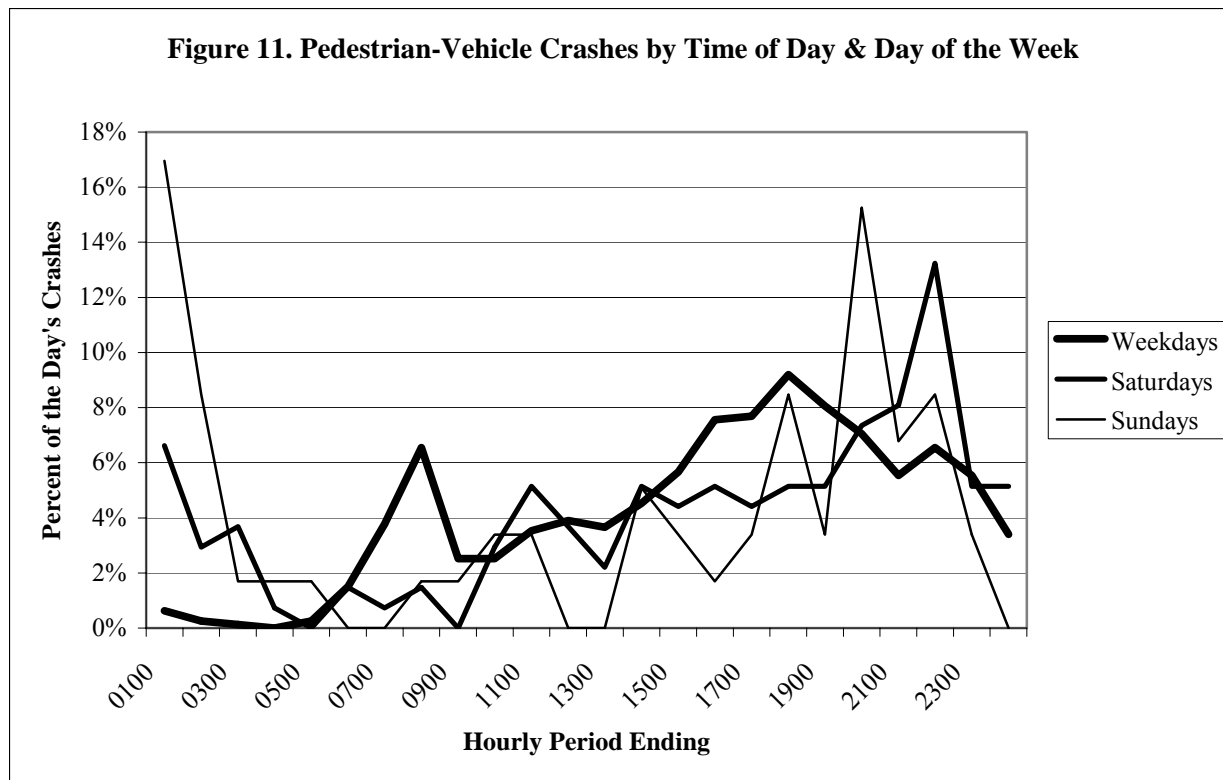
The possibility of a difference between the time-of-day distributions of crashes on weekdays and weekends was also investigated. The possibility of a difference between the time-of-day distributions of crashes on weekdays and weekends was also investigated. Time-of-day distributions for weekday (Monday-Friday), Saturday, and Sunday incidents were prepared. The distributions are displayed in Figure 9. It is evident that the greatest proportion of late evening and nighttime crashes, in comparison with that day's crashes, occurred on Saturdays and Sundays (i.e., Friday and Saturday night). These incidents may have been related to socio-recreational activities, perhaps involving the consumption of alcoholic beverages. Lighting conditions and visibility may have also been factors in these crashes.

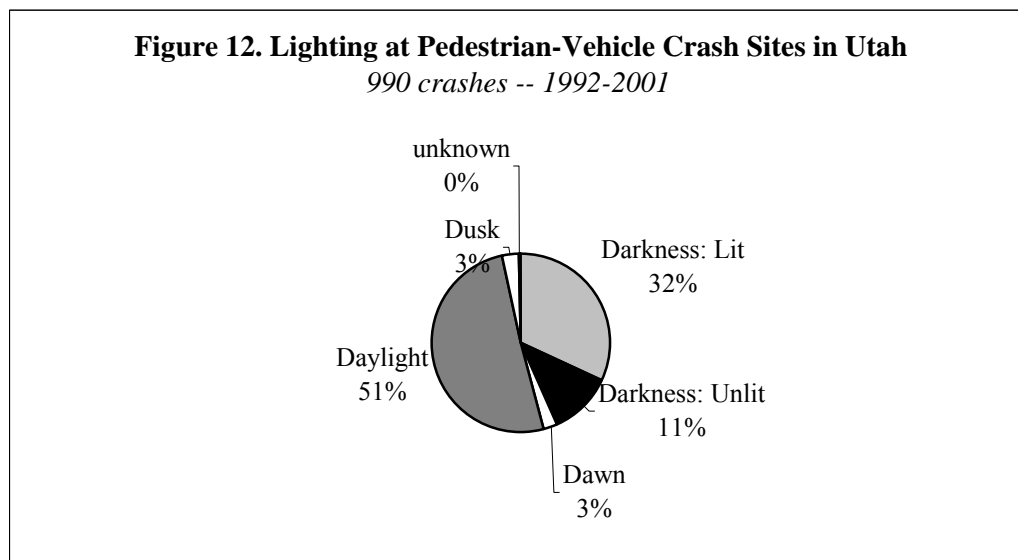
**Lighting Conditions.** One of five different lighting conditions is recorded in the CDDS for each pedestrian-vehicle crash: daylight, darkness with street or highway lighting, darkness with no lighting, dawn, or dusk. About half of the 990 sampled incidents (502 or 50.7%) occurred during daylight. A total of 429 incidents (43.3%) occurred during darkness. Of the crashes occurring in darkness, 73.9% occurred under street or highway lighting, while the remaining 26.1% occurred where there was no lighting. The remaining 55 incidents (5.6%) were split between dawn and dusk, while no entry was made for four of the incidents. One conclusion is that inadequate lighting may have been a causal factor in the 112 crashes (11.3% of all crashes) in which there was no lighting. It is likely that improved lighting conditions would be a remedial strategy in some of these cases. In contrast, other remedial strategies would be evident for the crashes that occurred in daylight. It is not known if the lighting was adequate in the cases in which a crash occurred at night under street or highway lights. Locations at which crashes recur at night should be considered for lighting improvements. An in-depth tabulation of locations having recurrent nighttime crashes was beyond the scope of this research. The lighting data are summarized in Figure 10.

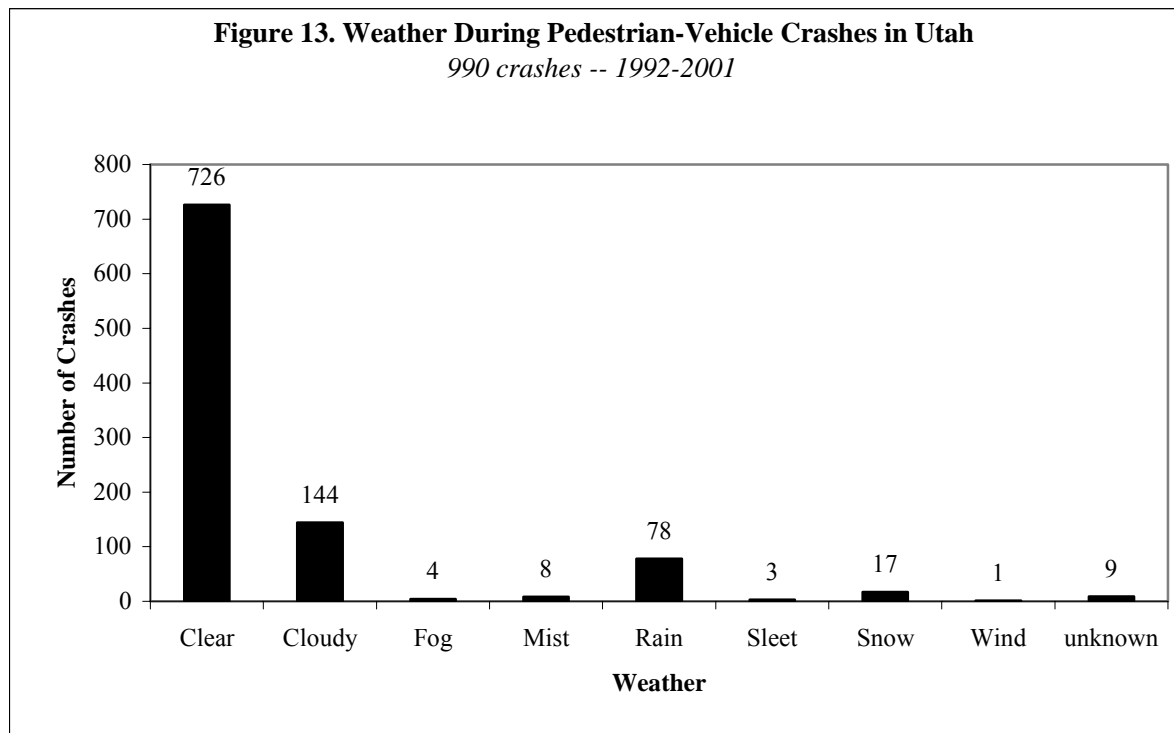
Weather. One of eight different weather conditions is recorded in the CDDS for each pedestrian-vehicle crash. A surprisingly large number of the 990 sampled incidents occurred during either clear (726 or 73.3%) or cloudy (144 or 14.5%) conditions. Of the remaining 120 incidents, 78 (7.9%) occurred during rain, 17 (1.7%) occurred during snow, 8 (0.8%) occurred during mist, 4 (0.4%) occurred during fog, 3 (0.3%) occurred during sleet, and 1(0.1%) occurred during a windstorm; the weather during nine of the

incidents was not recorded. The indication is that inclement weather conditions may have been a factor in about 11.2% of all incidents. The weather conditions data are displayed in Figure 11.

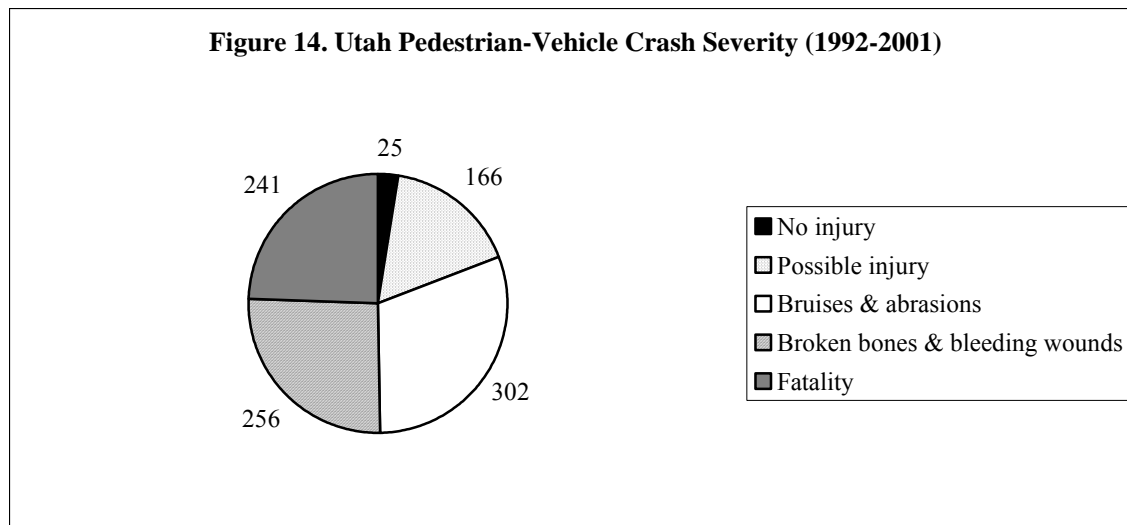
**Severity.** The emphasis in selecting the 294 pedestrian-vehicle crash sites was on those with high crash severity scores. The tendency among the 990 crashes at these sites, therefore, was toward severe crashes. As discussed earlier in this report, one of the five crash severity scores is recorded in the CDDS for each incident. As expected, “no injury,” the least severe result, occurred in only 25 (2.5%) of the crashes. A “possible injury” was the result in 166 (16.8%) of the crashes, while bruises and abrasions occurred in 302 (30.5%) of the crashes. The latter was the most common type of injury. Broken bones and bleeding wounds were the outcome in 256 (25.9%) of the incidents, and 241 (24.3%) of the crashes resulted in fatalities. The 241 fatalities in the sample represented 71.9% of all fatalities that resulted from pedestrian-vehicle crashes in Utah between 1992 and 2001. The severity data are presented in Figure 12.

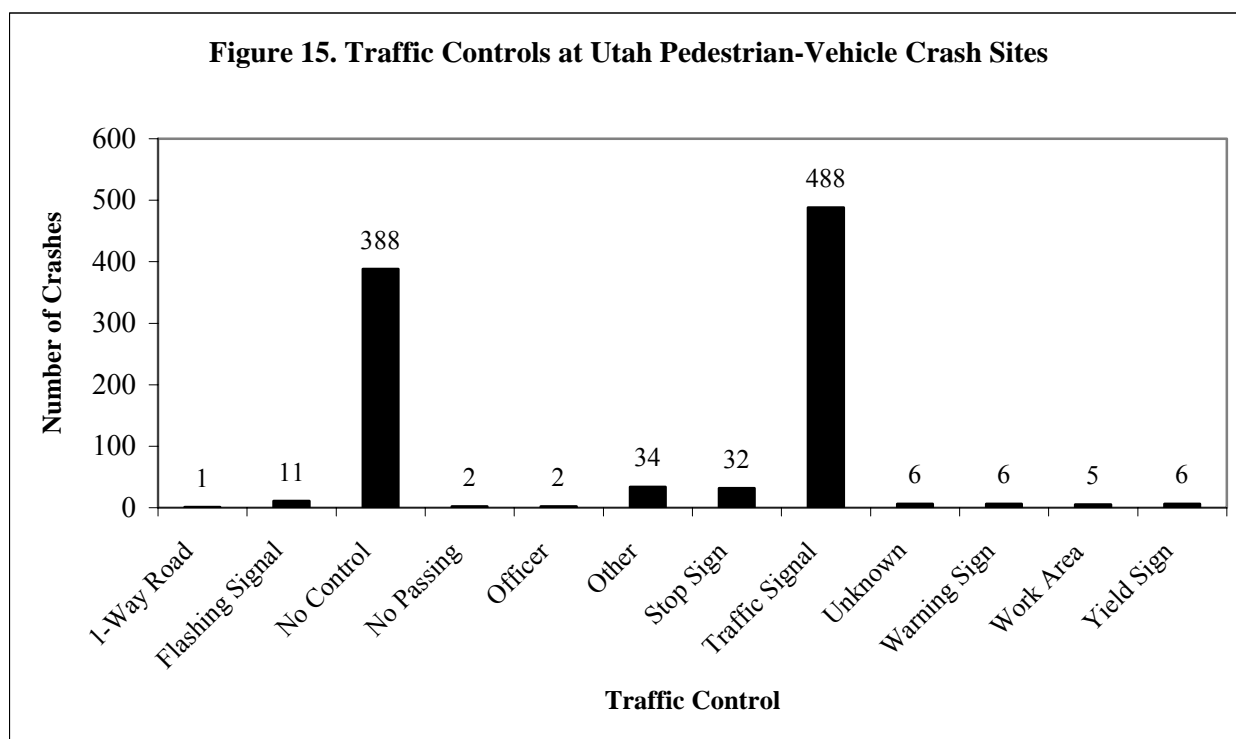
Given the above possibilities, the traffic control statistics shown in Figure 13 were observed for the 990 incidents. The majority of the incidents occurred at traffic signals (488 or 49.3%). Either "no control present" or "traffic lanes marked," both lumped together as "no control," was recorded for 388 incidents (39.2%). Only 32 crashes (3.2%) occurred at a stop sign-controlled location, while six occurred at a yield sign. A broad array of other types of control was recorded for the other crashes, including flashing signal (11 crashes or 1.1%), officer or flagman (2 crashes), warning sign (6 crashes), work area (5 crashes), and no passing zone (2 crashes). "Other" was recorded for 34 crashes (3.4%). Regarding the latter category, the type of control is supposed to be specified, but in no case was the type described. A total of 53.3% of the incidents occurred at a stop sign-, yield sign-, signal- or officer-controlled location. Locations in which the driver probably should have slowed because of a warning sign or highway work activity were the scene of 2.4% of the crashes. Most of the remaining crashes occurred at uncontrolled locations, as noted above. The implication is that just over half of the incidents occurred at controlled intersections.

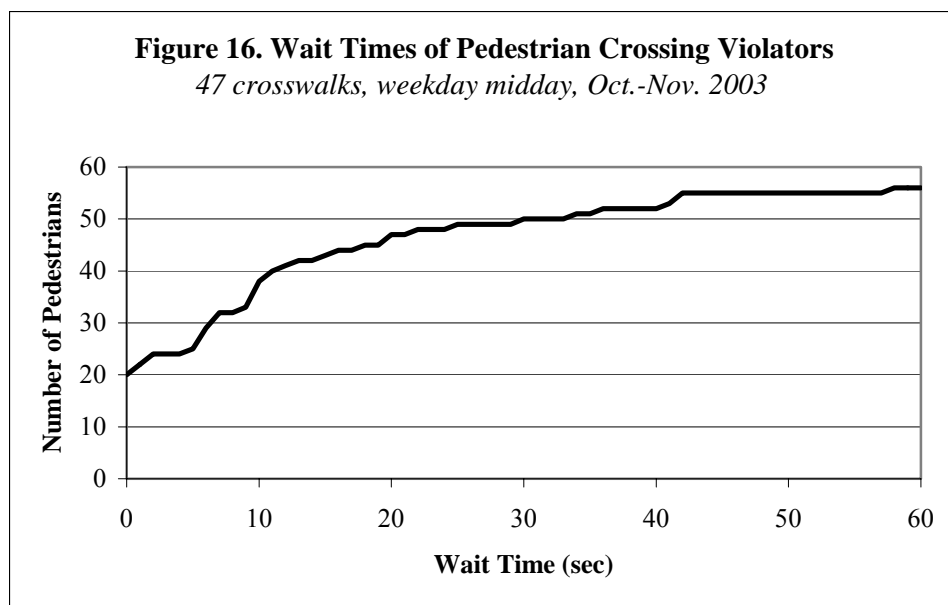
A total of 987 pedestrian “units” were observed at the 14 sites. Nearly all (881 or 89.3%) of the pedestrians or “group leaders” were adult or adolescent. A total of 66 (6.7%) pedestrian “units” were identified as elderly, 32 (3.2%) were identified as children, and eight (0.8%) were disabled. Most of the pedestrians – 570 or 57.8% -- arrived when the pedestrian signal was red. Of these, 512 (89.8%) waited until the “walking man” appeared before crossing. The remaining 58 pedestrian “units” acted in one of two fashions upon arriving on a red signal. A total of 38 persons or groups waited for a time ranging from 1 to 58 seconds, then violated the signal by crossing on a “steady hand.” The other 20 pedestrian “units” violated the signal and crossed without waiting. These findings indicate that some pedestrians, perhaps, grew impatient at having to wait a long time for a green signal. The distribution of wait times before a violation is presented in Figure 11. The figure shows that 24 pedestrian “units” waited for 0 to 2 seconds before violating the red crossing signal. An additional 14 persons or groups violated the red signal after waiting for 5 to 10 seconds. One criticism of pedestrian signals is that many are not quickly responsive to pedestrian actuation. These findings indicate, though, that only 20 (34.5%) of the violators had to wait for more than 10 seconds at any crossing. For 38 (65.5%) of the violators, the wait time was less than 10 seconds. In these cases, there was no opportunity for the pedestrian signal to “demonstrate” its responsiveness. It may be that these pedestrians based their decisions to violate on experiences with other, unresponsive signals; that is, it was assumed that the given signal would not be responsive, leading to a crossing during the “steady hand.” It may have also been that some or all of these pedestrians were impatient, such as those who crossed without waiting, and no response time would have been satisfactory. The only mitigation for this small group of pedestrians (10.2% of all who arrived on the red signal were violators; 6.7% of all who arrived on red waited 10 seconds or less) might be enforcement.

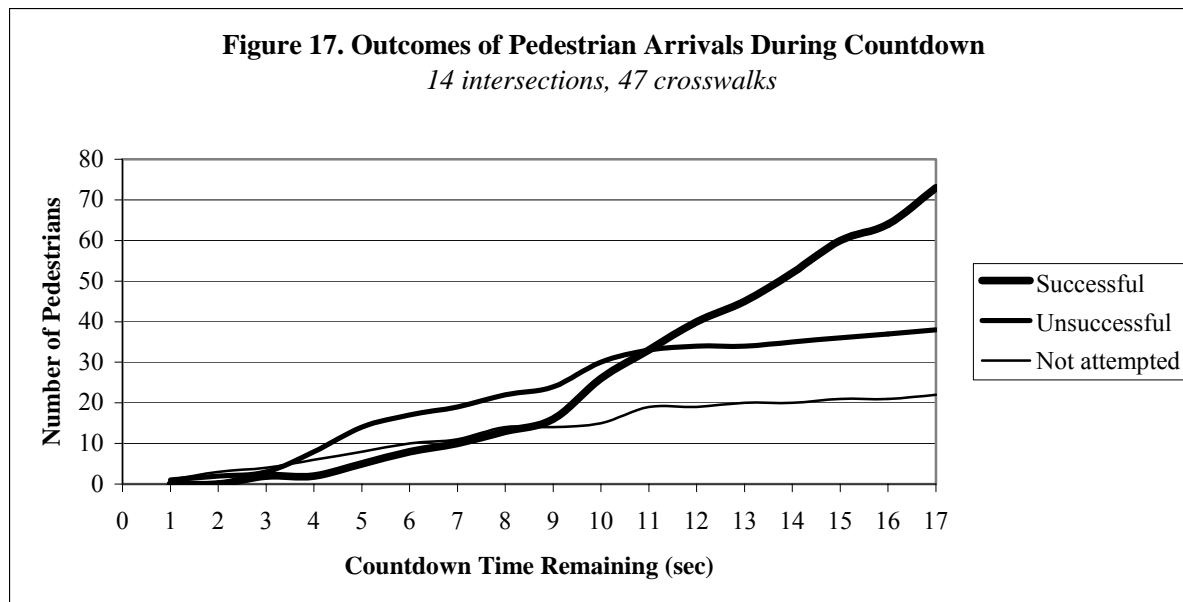
Further analysis of the pedestrians arriving during the countdown was done. The arrival times of the pedestrians were unevenly distributed among the countdown times. The number of arrivals ranged from two at CPI = 1 to 17 at CPI = 10. A uniform distribution of pedestrian arrival times would be ideal. Arrivals were recorded at each countdown time from 1 to 20 seconds; a single arriving “unit” was recorded for CPI = 23, CPI = 24, and CPI = 28. An ideal database would feature a large, uniform number of arrivals at each CPI time; then, the actions of the pedestrians as a function of CPI time could be evaluated. The width of the crossing would need to be incorporated into the analysis. The data are summarized in Figure 15 and Table 16. As expected, the portion of walkers who successfully completed a crossing decreased as the CPI decreased. Similarly, the portion of pedestrians who either stopped before crossing or crossed and were “caught” increased as the CPI decreased. Figure 12 shows that a “kernel” occurred between CPI = 9 and 11 sec. At CPI < 9 sec, the number of pedestrians who either did not attempt to cross or who were unsuccessful in crossing before the time expired was greater than the number who successfully crossed. At CPI > 11 sec, the number of pedestrians who were successful was greater than the number who either stopped or were unsuccessful. The 60 pedestrian “units” who either stopped or were unsuccessful might be classified as pedestrians who arrive at a CPI and cannot cross successfully. Of these 60, 22 (36.7%) made a “good” decision in choosing not to cross; that is, these pedestrian “units” were able to evaluate the time remaining and elected not to attempt the crossing. A total of 38 (63.3%) perhaps made a “bad” decision and proceeded to cross, getting caught in the intersection at CPI = 0. This finding suggests that a large portion of pedestrians were unable to properly assess the time remaining. A possible mitigation would be to supplement the CPI with a “recommended crossing time” (perhaps on a sign adjacent the ped head), or a “do not start” message within the ped head when the CPI reaches a limiting value. The research team observed that the shortest time at which a pedestrian *walked* and successfully crossed was six seconds. Successful crossings with little remaining CPI time were, as expected, associated with relatively narrow crossings (such as Highland Drive at 2100 East). Four successful crossings were made with CPI < 5 sec, but these pedestrians were all observed to be “runners,” either running to get across the street or ascertained to be out running for exercise. It is recommended that additional data be collected at intersections with CPIs to confirm these findings.
